**Application:** Mould Injection

**Product Group:** Filtration & Sai

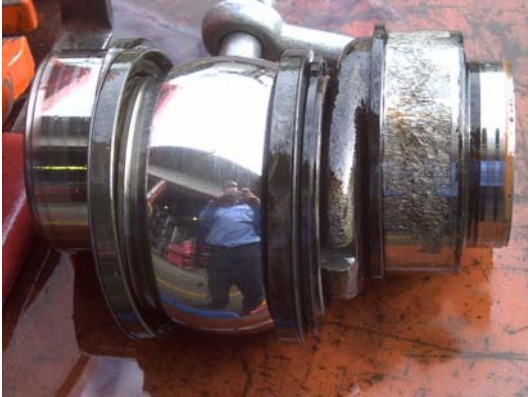
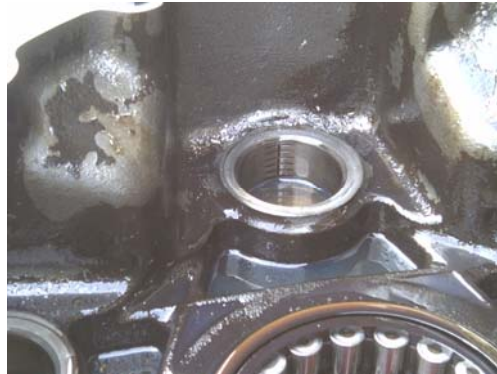
**Summary:** The customer had a complaint that the life of the Sai motor was not long. Upon further investigation it was found that the system was highly contaminated and causing wear, in turn reducing the life of the motor.

**Solution:** Put filtration in the system, pressure & return resulting in cleaner oil, less wear on the motor and less down time.
